**Historical and Architectural Impact Assessment Report for the
Port Durnford State Forest, Umhlatuze, Uthungulu District
Municipality**

March 2008

archaic consulting

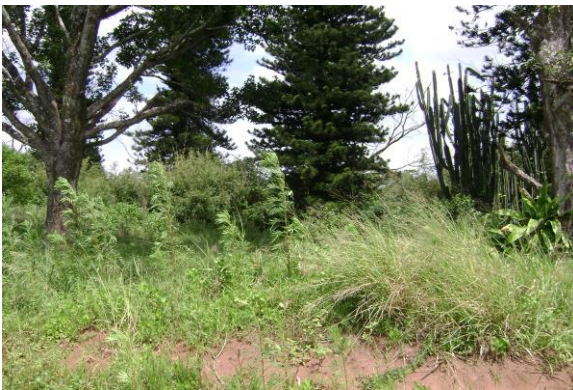
This is the first of the sites which has been demolished and bulldozed, and is really only evident from the uneven ground covering foundations, and the established trees. It appears as an early site from two pieces of evidence: the map above compiled in 1934, shows the forester's house in between the rail reserve and the adjoining Lot 171. In addition, Marwick notes in his volume, *KwaMahlathi*, that Forester F Noffke took up residence in Block A (this site) in 1915. However, what the material condition of this building was is uncertain, particularly as Marwick talks of the early foresters living in wattle and daub huts. "This officer eventually took up residence at Block A on 1 September 1915." (Marwick:1984:42) The 1937 Aerial photographs shows an indistinct but substantial building at this spot, and also a collection of buildings at the position on Fig A which shows the Umhlatuze Station. In addition, there exists a potential site which would also have been demolished, as seen on Fig 7.

Fig 4: Showing site

Condition of site: ruin

Recommendations: since this seems to be the oldest habitation site, the presence of an archaeologist during site clearing is recommended.

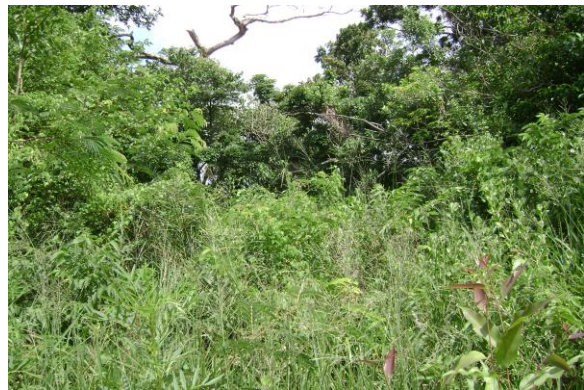
Fig 5: Showing site and vegetation

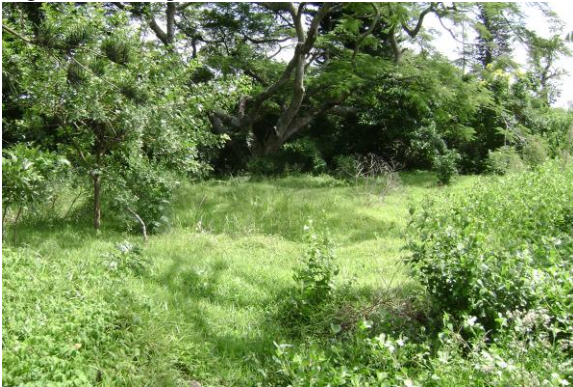
Fig 6: Showing site overgrown with grass

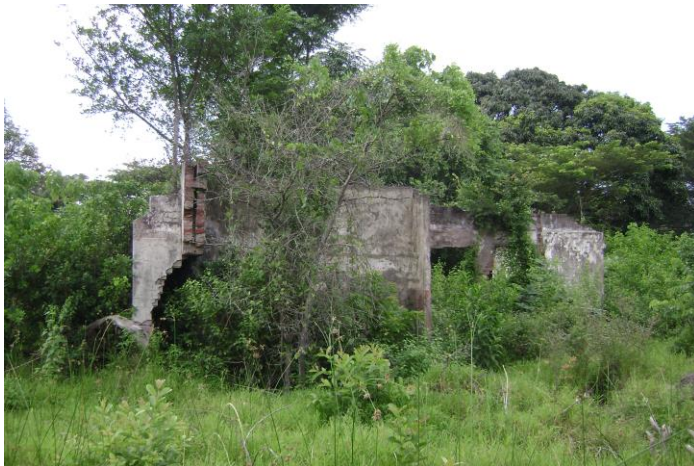
The remains of a dwelling, and concealed rainwater tanks are what is left of this site. The building has been largely destroyed, but some walls still remain to eaves level. The building is of conventional brick and mortar construction, and gauged from the occasional coursing built pre-World War II. No evidence has been found as to what this structure looked like, although its position may be seen on the 1937 aerial photo. (Fig 8)

Fig 9: ruined walls as remains of domestic structure

Condition of site: ruin except for water tanks

Recommendation: none and demolition of the rainwater tanks is recommended

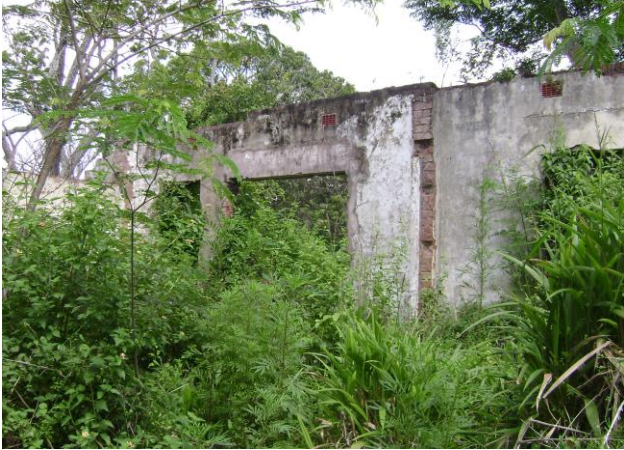
Fig 10: showing walls

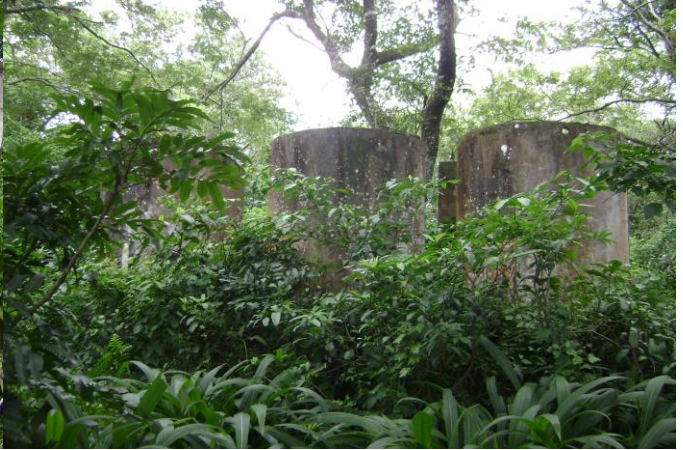
Fig 11: rainwater tanks

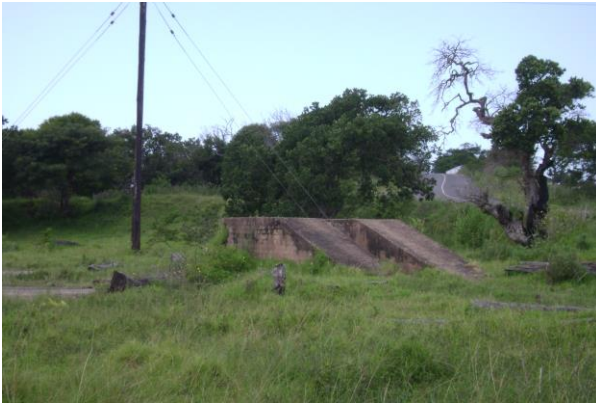
Fig 13: remnant of sawmill- loading ramps

Condition of site: ruin except for loading ramps

Recommendation: none and demolition of the loading ramps is recommended

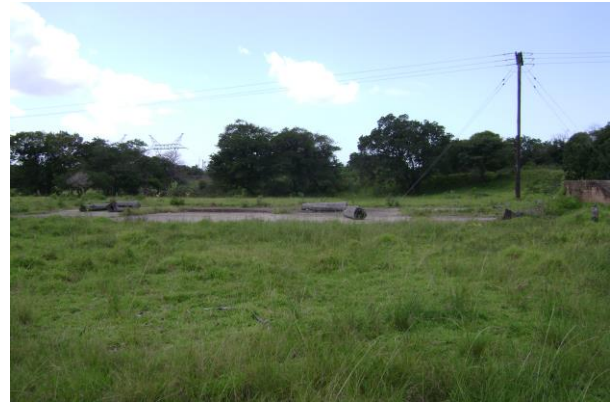
Fig 14: concrete platform and ramp (right)

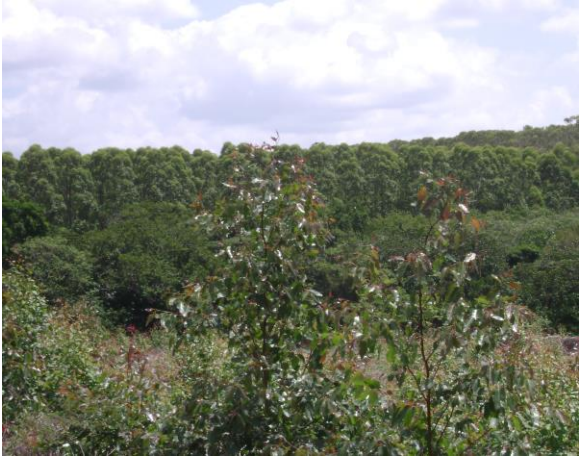
Fig 16: new trees over rubble

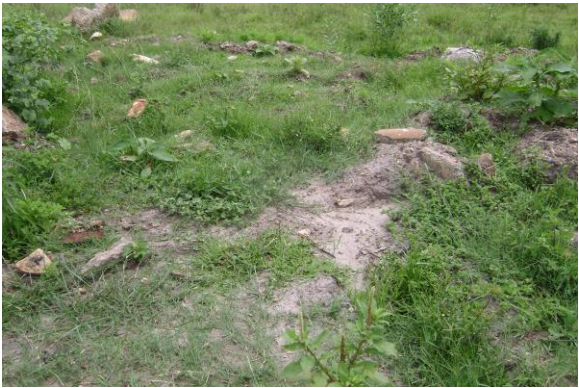
Fig 18: debris on site

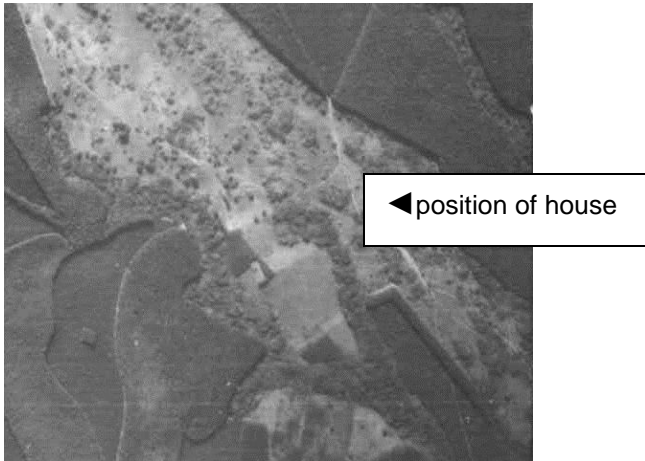
Fig 20: possible position of house

Condition of site: overgrown ruin

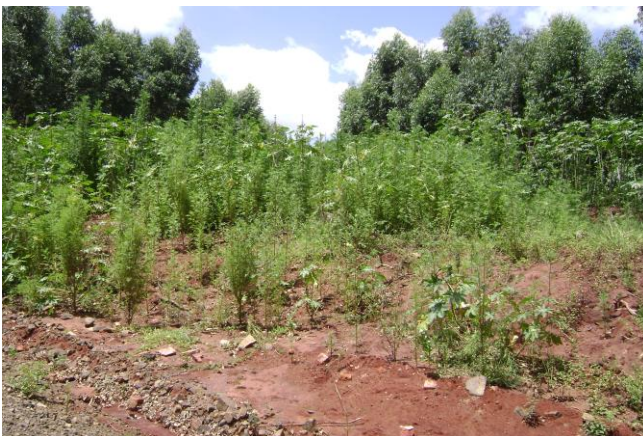
Fig 21: site of demolished house

Condition of site: overgrown ruin

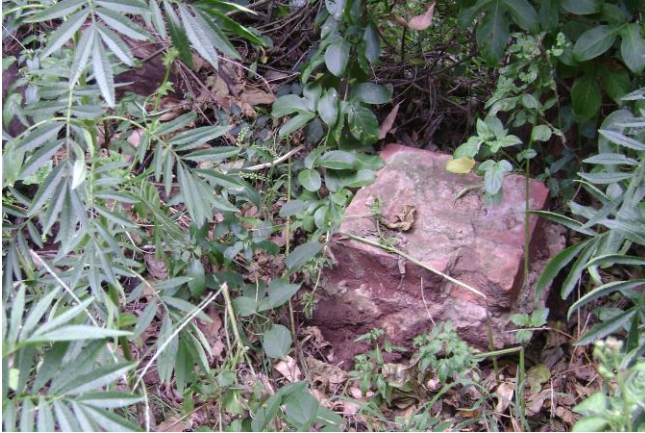
Fig 23: remnant of pillar in undergrowth

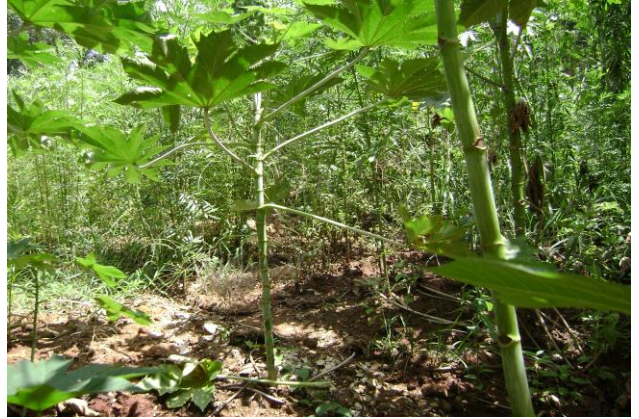
Fig 24: edge of foundation below soil

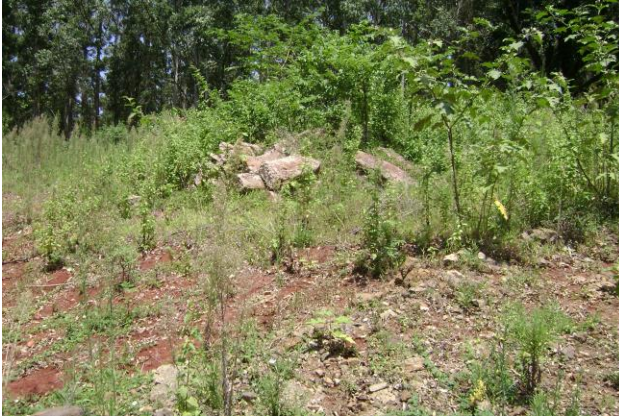
This site is identified as a Forester's encampment on the maps in Fig 2 and 3. Extensive bits of brick walling exist on the surface which has been extensively bulldozed. A water tower still stands.

Fig 26: bulldozed foundations with rubble on top

Condition of site: overgrown ruin

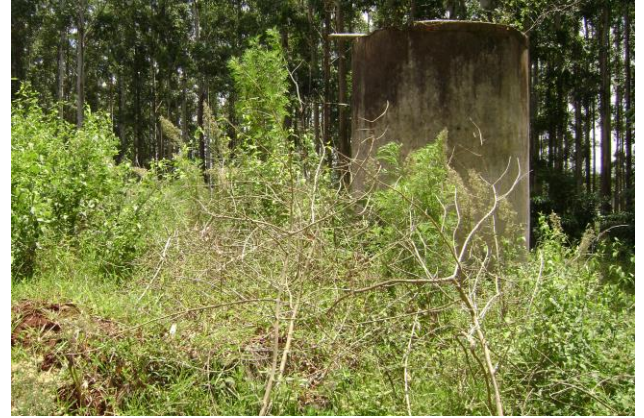
Fig 27: remaining water tower

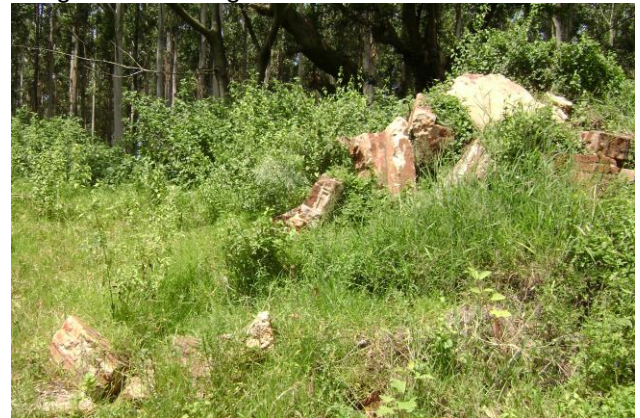
Fig 29: close up of foundation rubble

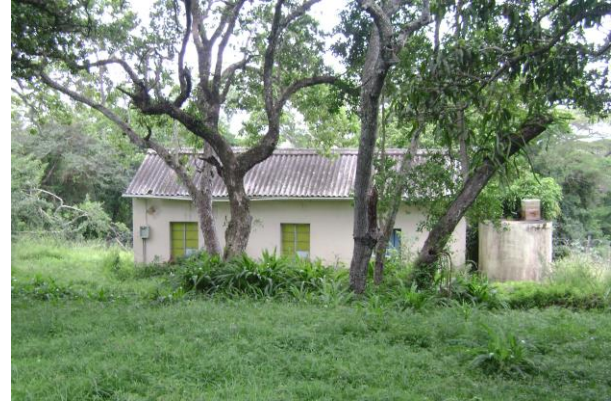
Buildings no 1, 2, 7 and 8 are enclosed housing complexes, largely of latter construction but no 7 likely to fall in within Amafa protection. Building no 3 is a small cottage, possibly built in the 1950's. Building no 4 is a garage complex and has little to merit if except for a large shed. Buildings no 5 and 6 are ill-maintained, ill-inhabited and have little merit, although they are likely to be older than 60 years.

Fig 46: derelict building no 5

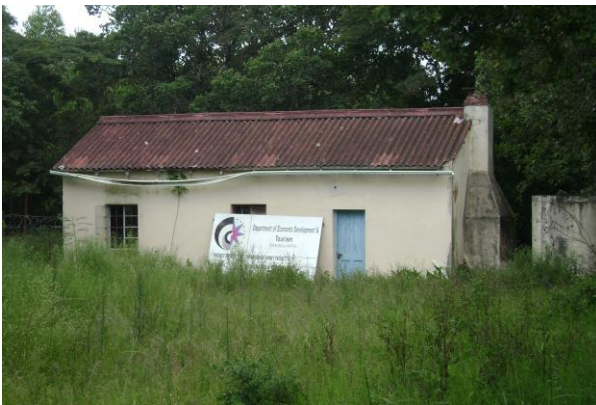
Fig 47: derelict building no 6

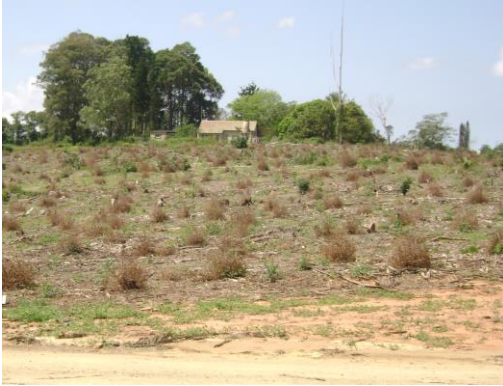
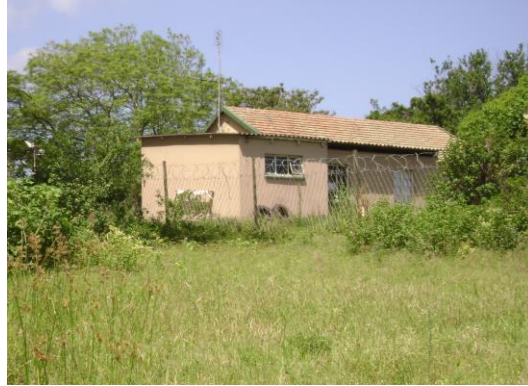
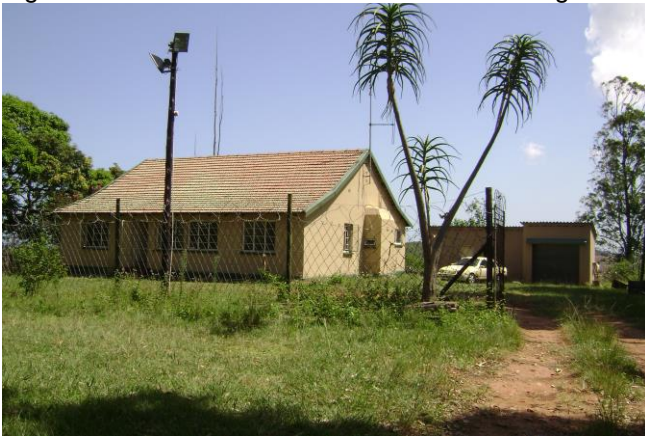
This structure was not identified in the Umlando report but does form part of the architectural impact assessment. It is of the same period as complex no 7 in the previous section, a simple tiled, saddled roof over a masonry structure. It is suspected that the building is either older than 60 years, or constructed soon after World War II.

Condition of site: the building is generally in good order. It is architecturally not significant. It does not operate as part of a group, nor does it form streetscape. It is not associated with any major event nor person.

Recommendation: should demolition be requested, this building is not deemed significant with regards to the heritage of the province of KwaZulu-Natal.

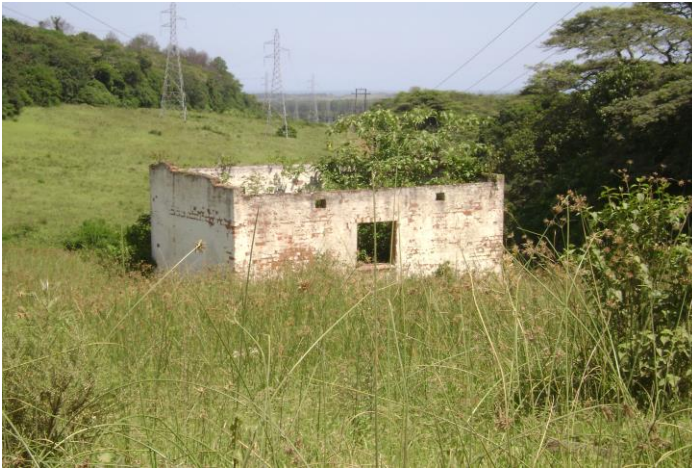
Fig 51: ruined structure

This is a partly demolished structure south of the main entrance. It was not identified as part of the archaeological impact assessment. It was built in around 1940.

Condition of site: ruin

Recommendation: should demolition be requested, this ruin is not significant with regards to the heritage of the province of KwaZulu-Natal.

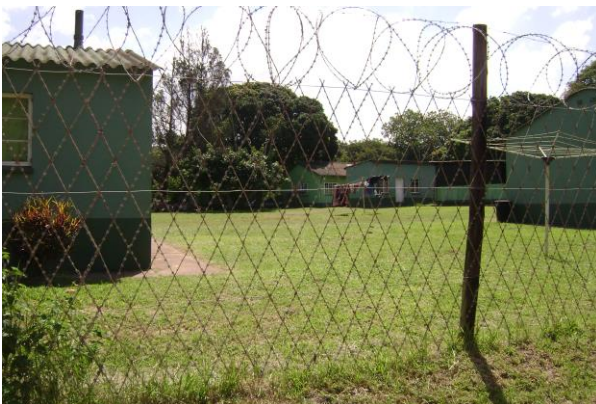
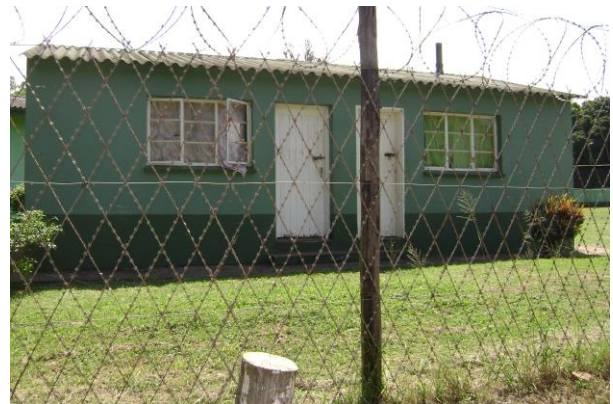
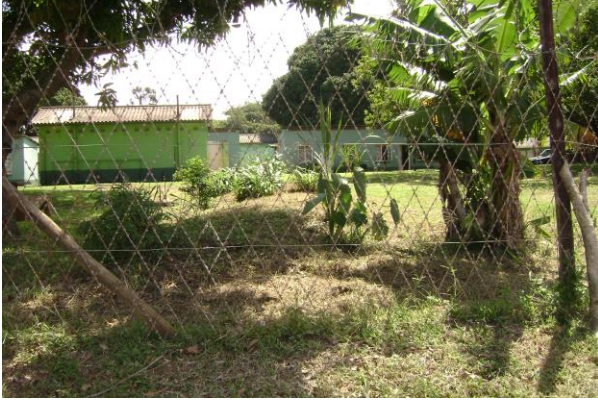
As with the previous structure, this was not identified under the archaeological impact assessment. It is a workers camp, of itinerant construction, with some of the older buildings being constructed out of asbestos sheeting. They are constructed of concrete block with steel windows.

Condition of site: the buildings are generally in good order. They are architecturally not significant, although they are good examples of functional buildings. They do operate as a group, but not as a streetscape, and are not associated with any major event nor person. They are remote from Empangeni and Mtunzini and their situation limits alternative uses. They are constructed of mixed materials, but largely concrete block and asbestos. It is suggested that they were constructed post-war.

Recommendation: should demolition be requested, this group of buildings is not significant with regards to the heritage of the province of KwaZulu-Natal.
